RSP HOSE CARE

For longer life.

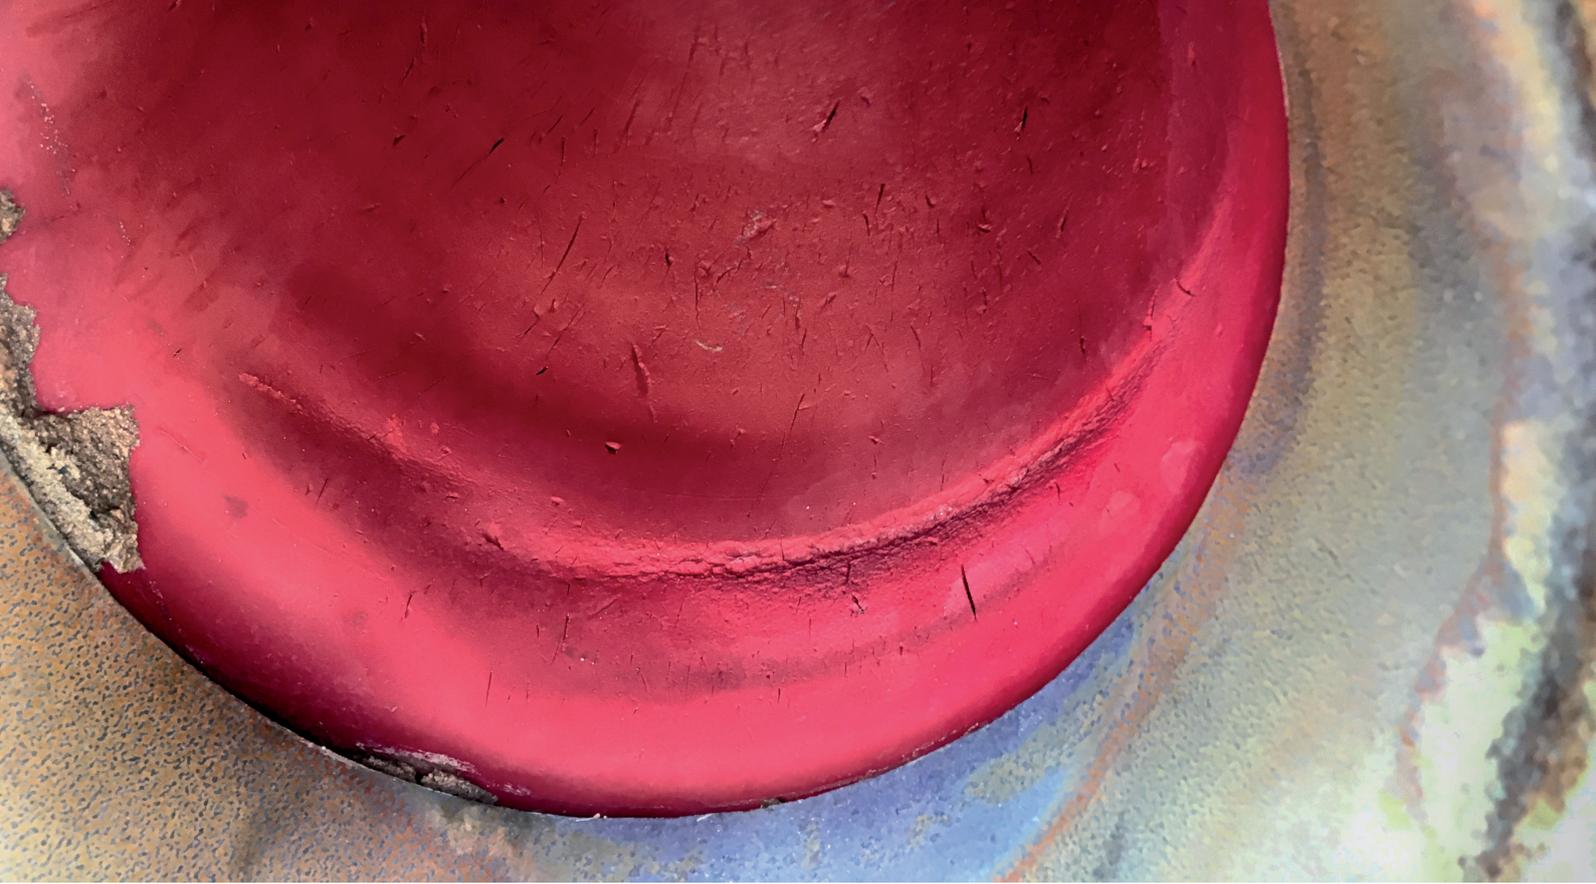
Reduce wear.

A suction excavator works with high flow velocities. These attack the inside wall of the hose aggressively depending on material or suction material. The joint hose carrier with the hydraulic cylinders exerts great forces on the suction hose, and generally a 90° angle (or greater) should be avoided.

Through the control of the individual arm links the slipping can be controlled and compression and lengthening of the suction hose avoided.

Misalignment of the joint hose carrier is a particularly common cause of the early onset of wear. This must be avoided. If an RSP suction hose is sucked through from inside to the outside it is damaged and constitutes an unsealed system.

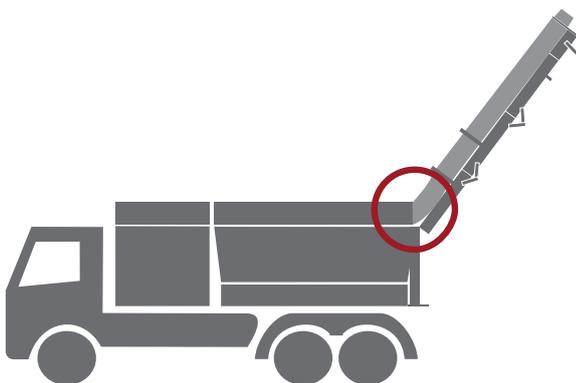
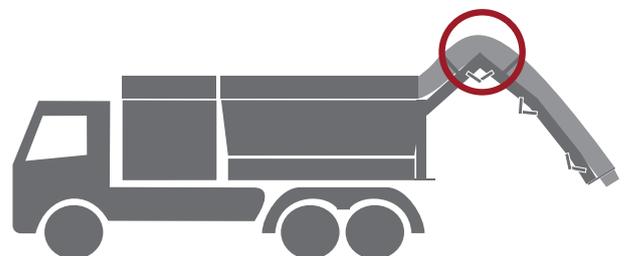
Extreme forces occur when opening the lid into the transport position. Here the suction hose is pinched in the joint hose carrier and the suction inlet of the cover moves away from the vehicle due to the tipping kinematics, which causes the last freely movable part of the suction hose to be severely stretched in particular.

Avoid this error.

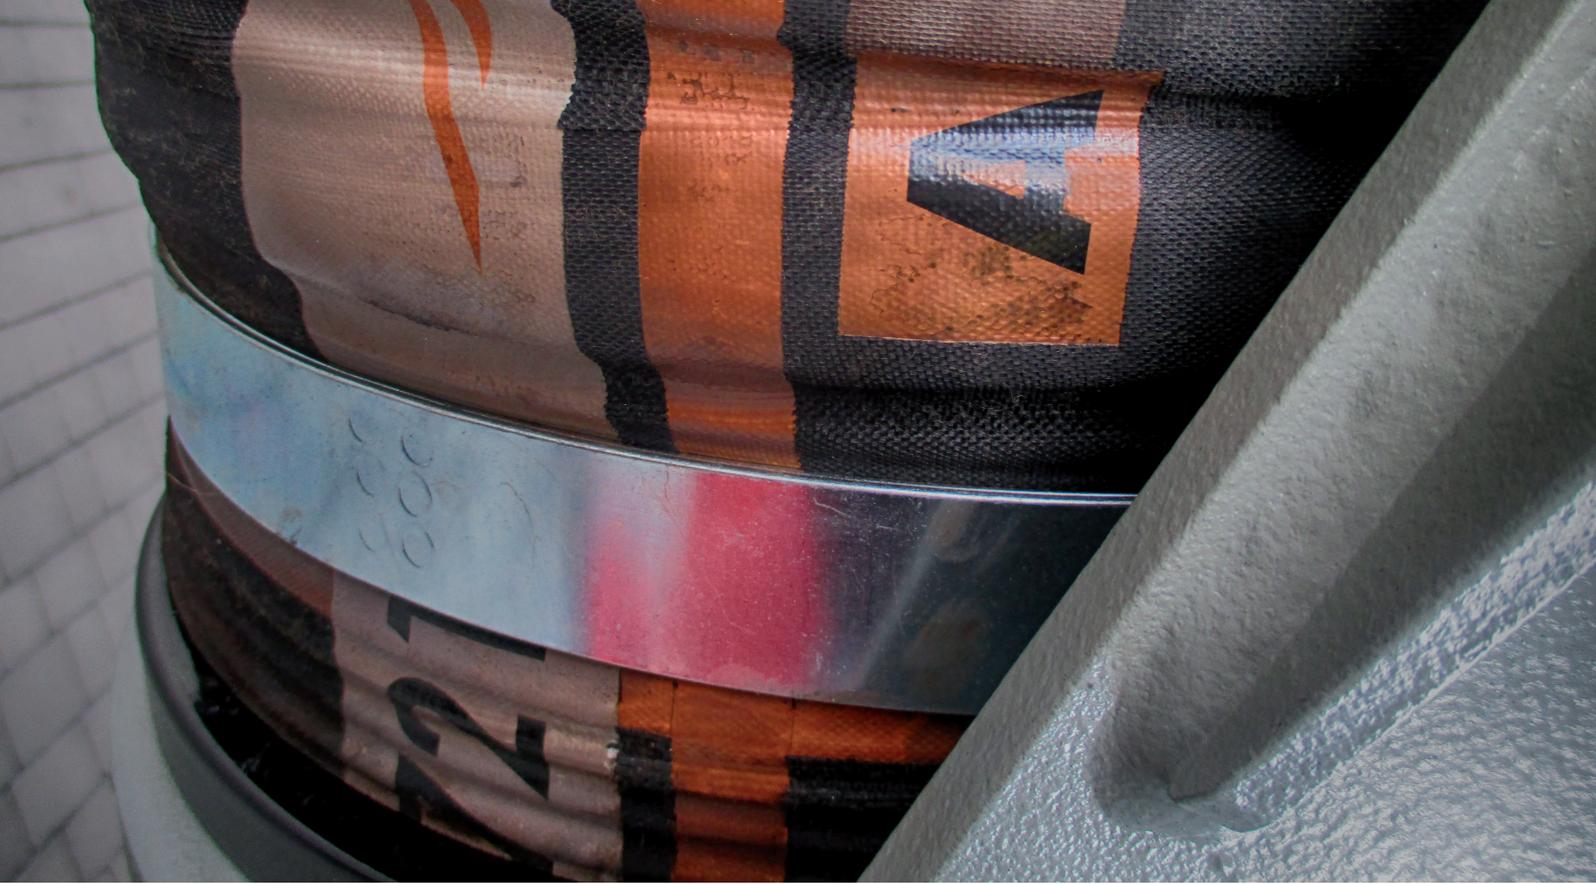
Influences and factors.

Due to the necessary material composition, conductive suction hoses must be assumed to have a lower life span.

Sharp-edged material, chemicals, gases and organic substances for example from biogas plants can cause deterioration inside the suction hose and also reduce the service life.

Single-sided internal damage does not necessarily require a change of the entire suction hose but only new positioning. The various positions are identified by letters A-D on the suction hose.

Each suction hose is provided with markings at the end of the hose every 90°. The letters A - D clearly show the last used position.

The suction hose can be rotated several times depending on the wear, to position the damaged area differently. The RSP suction hose can also be turned as well from the cover side to the end of the hose carrier which reverses its direction of flow.
